## **REGION 6 EXECUTIVE SUMMARY**

TOPIC: San Jacinto River Waste Pits Superfund Site

DATE: December 18, 2015

PURPOSE: For Information – EPA Dive Team Inspection

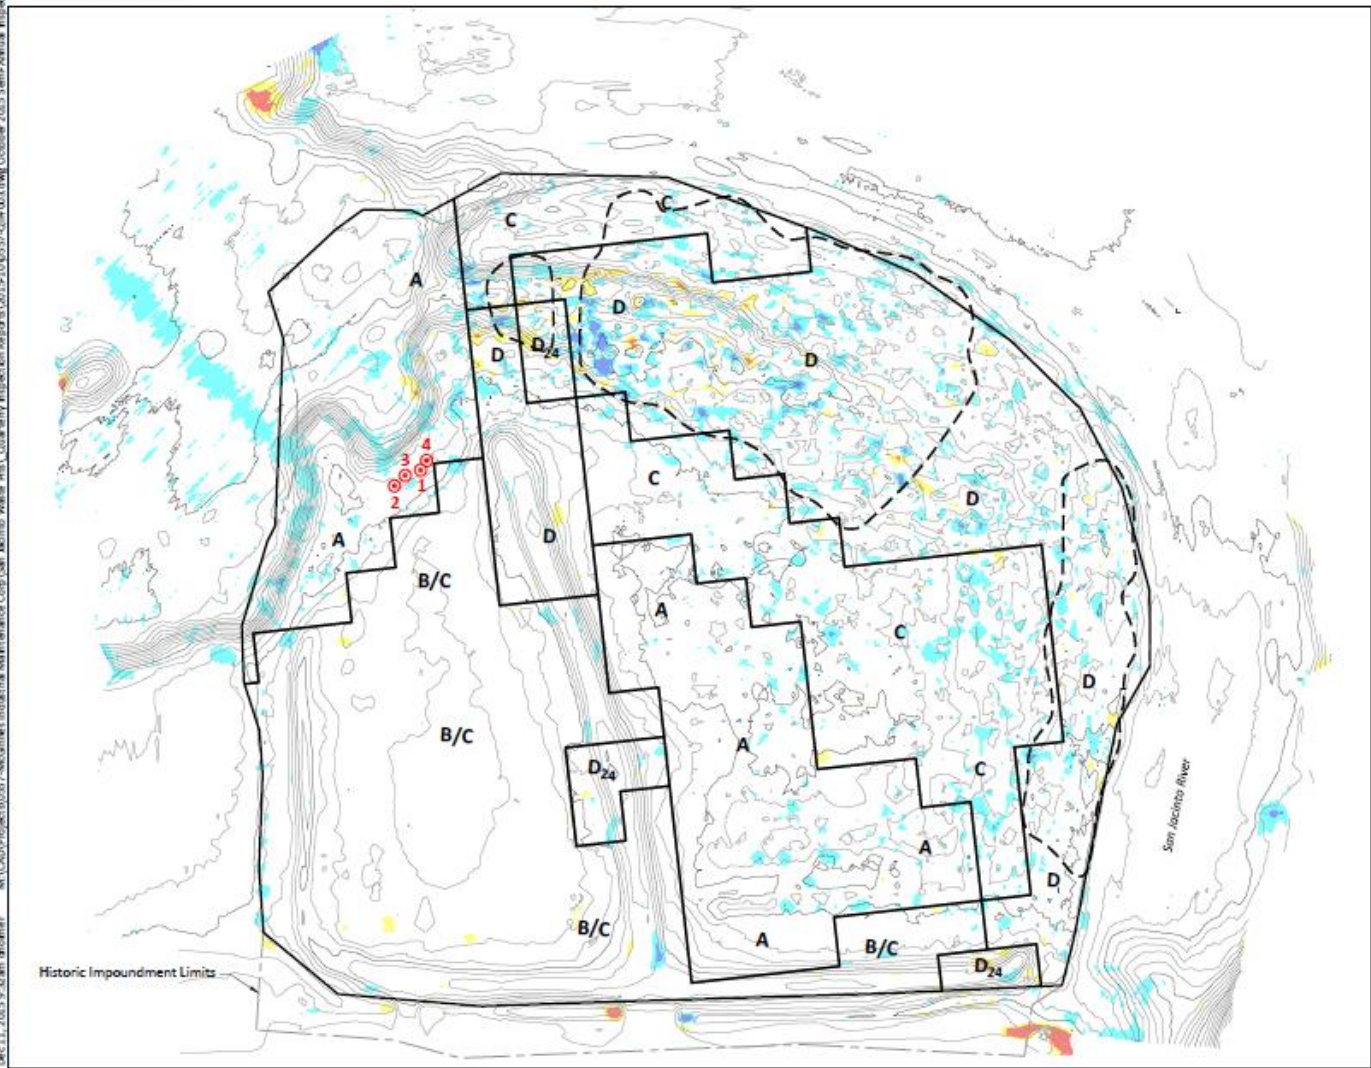
The EPA Dive Team completed work at the Site on December 10, 2015, that included an inspection of the submerged portions of the armored cap. A gap was found in the armored cap in the northwest area (see attached). The gap area was not fully delineated, but is at least 17-feet across.

- Absence of the armor rock could expose contaminated soils and may result in a release of dioxins/furans to the San Jacinto River.

- Develop fact sheet to notify community on inspection results & repair plans. (Dec 21)
- Receive draft repair plan early next week. (Dec 21)
- Delineate gap area & repair cap as soon as possible. (January 2016)
- Sample sediment in gap area during delineation. (January 2016)
- Sample cap repair area during pore water sampling. (January/February 2016)
- Develop enhanced inspection plan. (February 2016)
